Kevin Kamenetz, County Executive
Vincent J. Gardina, Director
Department of Environmental Protection, and Sustainability
March 2015

**Liberty Reservoir Watershed Characterization Report**

# Liberty Reservoir Watershed Characterization Report

March 2015 FINAL

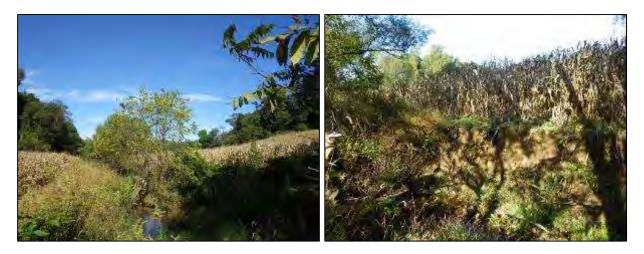
The severity of inadequate stream buffers was rated according to length and width. The most severe rating (very severe) of 1 would be given to inadequate buffer lengths with limited or no trees on either stream bank and no evidence that a tree buffer is beginning to form for a significant length of stream. The existing land use was also taken into consideration, such as pavement, lawn, agriculture, or shrubs and trees. The highest inadequate buffer rating assigned in the three assessed subwatersheds was severe. Four of the sites were in Cliffs Branch while Keyser Run and Norris Run each contained one severe rating. Two of the sites are shown in Figure 3-8. Most sites were rated between moderate (3) and minor (5). Stream buffer restoration potential depends on various factors such as accessibility, property ownership, and current land use. Many of the more severe inadequate buffer sites in the watershed were due to land clearing up to the stream banks for use as cropland or pasture leaving the stream completely unshaded.

Figure 3-8: Examples of Severe Inadequate Stream Buffer Locations in Cliffs Branch

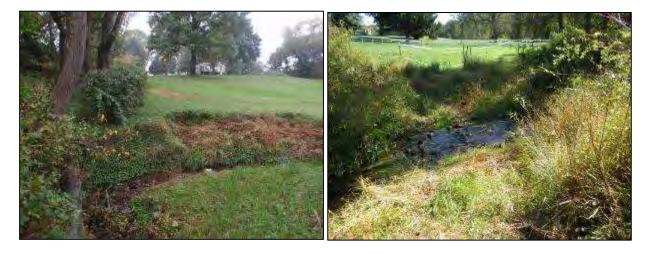
The majority of the inadequate buffer sites (59%) were located in Cliffs Branch subwatershed; approximately 33% of all streams assessed were identified as having some sort of inadequate buffer. Many of the inadequate buffers are due to cropland and pastures bordering stream segments or lawns as seen in Figure 3-9. Approximately 93% of the inadequate buffer sites ranked between minor to moderate in severity. Of the 94 sites, roughly 29% were reported as being unshaded on both banks; these conditions can be detrimental to aquatic life as shade protects streams from excessive solar heating. The locations of stream segments with inadequate buffers and their corresponding severity ratings are shown in Figure 3-10. Appendix A provides tables of inadequate buffer data ranked by severity for the Liberty Reservoir watershed.

Figure 3-9: Example of Inadequate Buffer in Cliffs Branch Due to Lawn (Left) and Keyser Run Due to Cleared Pasture (Right)

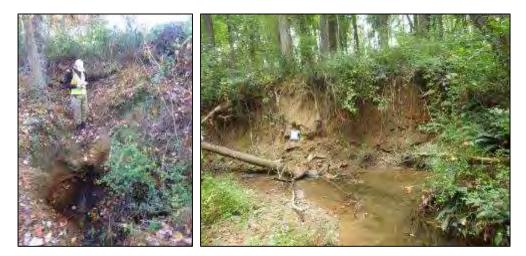
Figure 3-11 shows an example of a very severe and severe erosion site. The figure on the left is of site 031C2\_09-ES a very severe erosion site near Old Hanover Road with eight foot vertical bank heights over a 250 foot distance. The figure on the right is of site 039A1\_02-ES, a severe erosion site in Cliffs Branch

with nine foot vertical bank heights over a 70 foot distance. The very severe erosion site is incising, while the severe erosion site is widening at a bend. The location of all erosion sites can be seen in Figure 3-12.

Figure 3-11: Example of a Very Severe Erosion Site (Left) and a Severe Erosion Site (Right) both located in Cliffs Branch

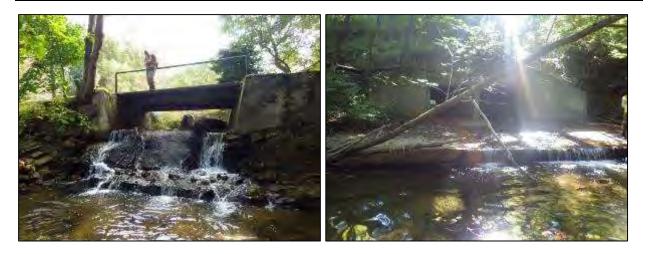
Figure 3-13 shows a very severe and severe road crossing fish barrier where the drop between the culvert and the natural channel is too high for the fish to pass and/or too shallow. Figure 3-14 shows two naturally occurring fish migration barrier sites due to natural falls that are too high and too fast for fish to pass through. In all cases, the location of the fish barrier within the subwatershed has an impact on the severity rating.

Figure 3-13: Example of a Very Severe Road Crossing Fish Barrier in Keyser Run (Left) and Moderate Road Crossing Fish Barrier in Norris Run (Right)

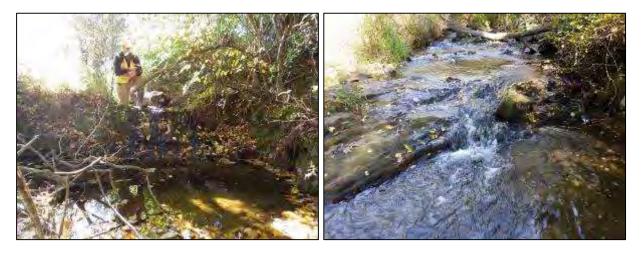
Figure 3-14: Examples of Low Severity (Left) and Moderate (Right) Natural Falls Fish Barriers in Keyser Run

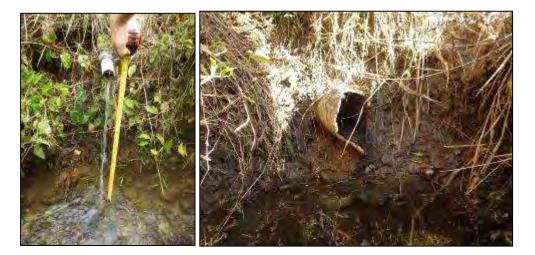
Figure 3-15: Moderate Pipe Outfalls with Active Discharge

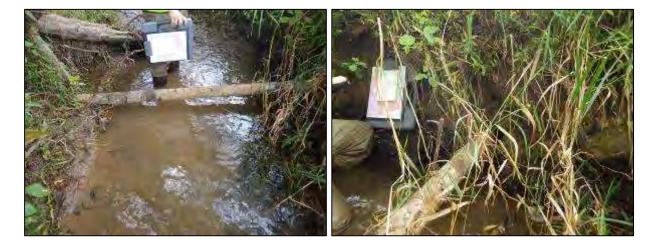
Only one exposed pipe was observed during the Liberty Reservoir SCAs (Table 3-27). The exposed pipe in Cliffs Branch had an unknown use, was found running perpendicular with the stream, and was completely exposed across the entire bottom width of the channel with a high risk of puncture (Figure 3-16).

Figure 3-16: An Exposed Pipe in Cliffs Branch with Moderate Severity

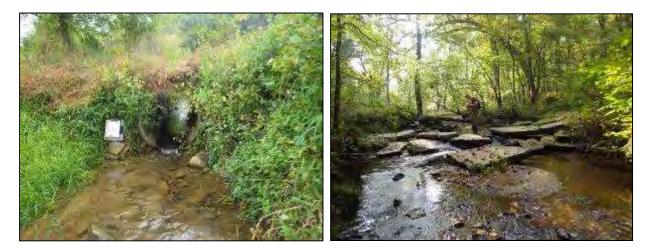
Figure 3-17: Examples of two moderate Channel Alteration for the creation of private roads either by piping the stream as shown in Cliffs Branch (Left) or by creating a ford to pass through the stream as shown in Keyser Run (Right)

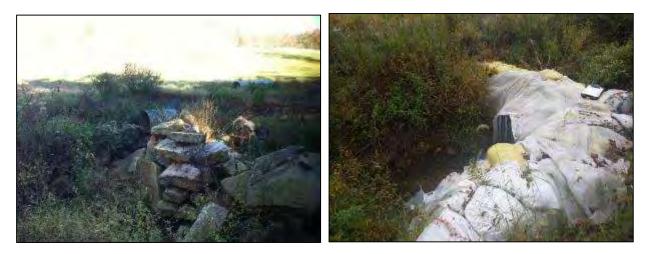
Figure 3-18: Example of Channel Alteration due to Rip-Rap in Cliffs Branch (Left) and a Sand Bag Dike in Norris Run (Right)

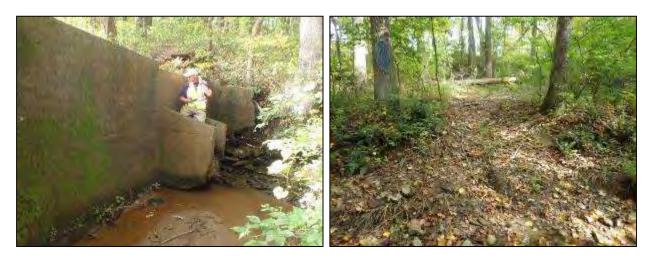
Table 3-30 summarizes the number of unusual conditions sites and their severity rating. Only three severe unusual conditions were observed; the remaining 33 unusual conditions were rated moderate or below. Examples of some of the unusual conditions observed are shown in Figure 3-20. One common unusual condition was the presence of all-terrain vehicle (ATV) trails that crossed the streams. Locations of unusual conditions sites are shown on Figure 3-22 through Figure 3-24. Appendix A provides tables of unusual conditions site data ranked by severity for the Liberty Reservoir watershed.

Figure 3-20: Examples of Unusual Conditions – Remnant dam structure with a stream bypass in Norris Run (Left) and ATV trail stream crossing in Keyser Run (Right)

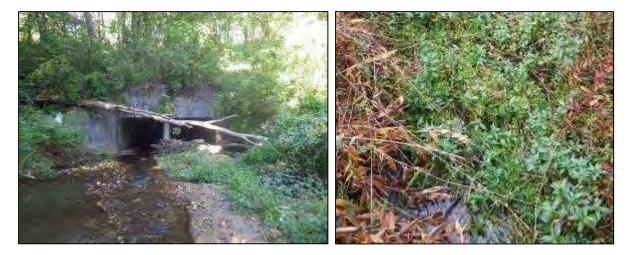
Table 3-31 summarizes the number of sites with comments and their severity rating. One comment site was rated moderate and was the highest rating given; the remaining eight sites were low severity and minor rankings. A couple of examples of unusual comments are shown in Figure 3-21. Locations of sites with comments are shown on Figure 3-22 through Figure 3-24. Appendix A provides tables of comment site data ranked by severity for the Liberty Reservoir watershed.

Figure 3-21: Examples of Comments – Debris Jam Upstream of Box Culvert (Left) and a mint patch growing in the middle of the channel (Right)

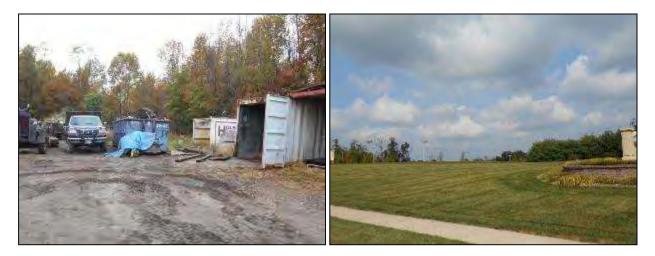
Figure 4-13: Future education efforts recommended to improve trash management and lawn care practices

sources for these facilities were vehicle operations, outside storage, and physical plant that may be contributors to sediment accumulation around these sites. Future education was recommended to improve waste management and lawn care and increase bayscaping (Figure 4-13). Runoff from these

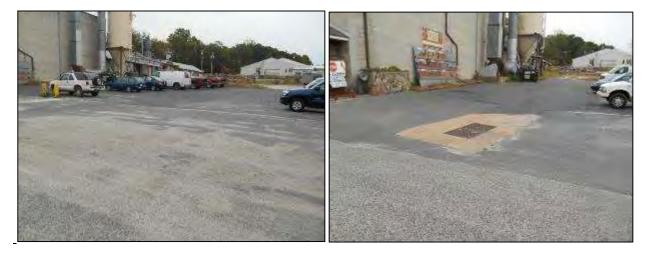
areas can go directly into the storm drain system along with certain pollutants depending on the type of materials (Figure 4-14).

Figure 4-14: Sediment accumulation on pavement and around storm drain

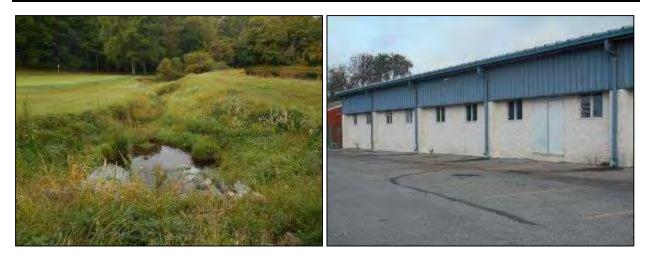
There were a couple of commercial recreational facilities in the watershed, including a roller skating rink and a golf course. These facilities are often prone to pollution from waste management and physical plant sources. In the Liberty Reservoir watershed, specific sources of potential pollution were lack of a stream buffer and downspouts directly connected to impervious surfaces (Figure 4-15). Both facilities have the potential for Stormwater Management (SWM) retrofits. The golf course currently has a pond that could be converted into a treatment pond while the skating rink has available space to install a SWM facility to treat the parking lot (Figure 4-16).

Figure 4-15: Lack of a buffer around stream (Left) and Downspouts Connected to Impervious Surface (Right)

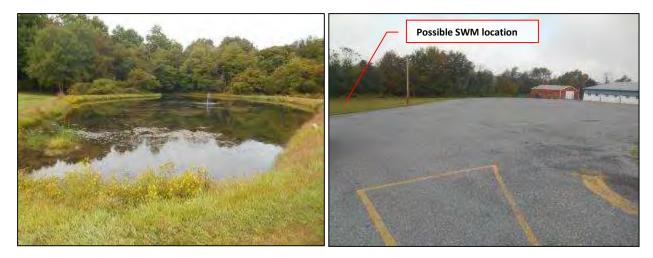
Figure 4-16: Potential SWM retrofit opportunities

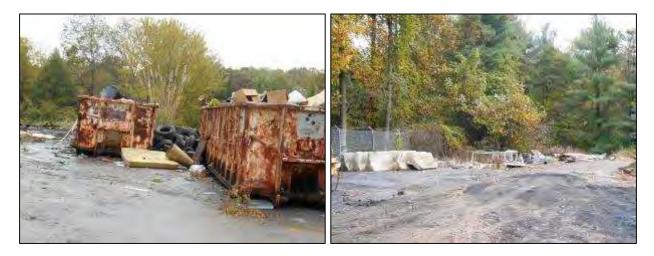
One municipal facility, a Baltimore County Highway Shop, was examined during the HSI assessments. The pollution sources observed were vehicle fueling and storage, outdoor storage, presence of garbage, and downspouts discharging to impervious surfaces. This facility had a large impervious lot with an uncovered fueling station, improper storage of outdoor materials, excess sediment available to leave the site, and overflowing dumpsters. Recommendations have been made for better trash management, improved

Figure 4-20: Improper waste management (Left) and significant sediment observed on pavement (Right)

stockpiling, and a review of the Stormwater Pollution Prevention Plan due to high volumes of sediment on impervious surfaces (see Figure 4-20). Stormwater management was observed (see Figure 4-21).

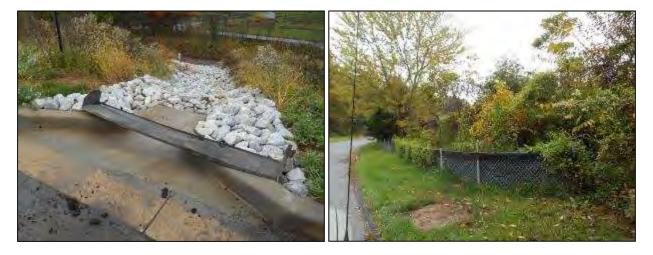
Figure 4-21: Stormwater Management facility (Left) and super silt fence (Right) observed on site

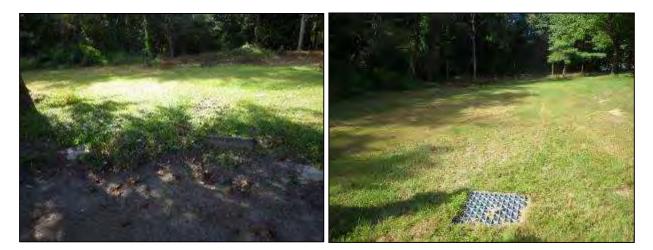
Another facility that could potentially be treated by bioretention is site ISI\_S\_0702. This is a faith-based site that has portions of its parking lot drain to a low spot near an open area where sediment accumulates (Figure 4-24). It is possible that the broken up curb and gutter be removed from the down gradient edge

Figure 4-24: Parking lot retrofit opportunity at ISI\_S\_0702

of the parking lot and a bioretention facility be installed at the perimeter of the parking lot to treat runoff. The open space has an inlet that currently drains runoff to a nearby stream.

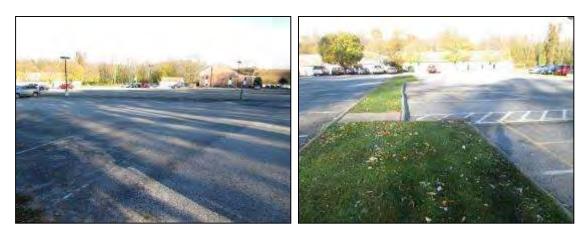
Figure 4-25: Parking lot retrofit opportunities at ISI\_S\_1301

Another facility where the parking lot could potentially be treated by bioswale stormwater retrofits is shown in Figure 4-25. Bioswales are similar to microbioretention in that stormwater treatment is provided with plantings in a special soil mixture; however, bioswales are linear facilities that usually receive sheet flow. ISI\_S\_1301 is a church and school where space could potentially be made for multiple bioswales by removing adjacent excess pavement and expanding medians. Stormwater currently sheet flows off of the parking lot and into an inlet. ISI\_S\_0101, ISI\_S\_0202, ISI\_S\_0702, ISI\_S\_0704, and ISI\_S\_0706 are all churches that have impervious areas from parking lots without curbs where runoff could be directed into bioswales or urban filter strips.

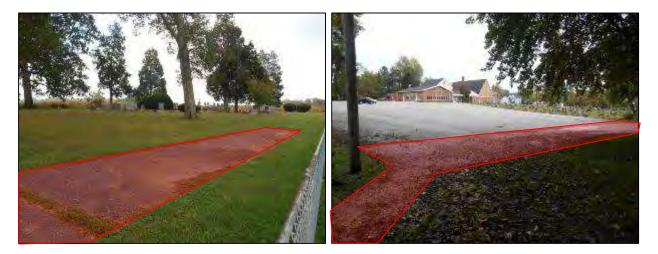
Figure 4-27: Examples of impervious cover removal opportunities at ISI\_S\_0204 (Left) and ISI\_S\_0704 (Right).

At site ISI\_S\_0204, an unused strip of pavement can be removed and planted as illustrated in Figure 4-27. Other examples where impervious cover can be removed are large unused impervious areas behind churches. At sites ISI\_S\_0701 and ISI\_S\_0703, broken up impervious walkways and parking lots were observed on the school properties. Much of the impervious area at the specified locations on each site can be removed and replaced with grass or bayscaping. Depending on how often the parking lot is used

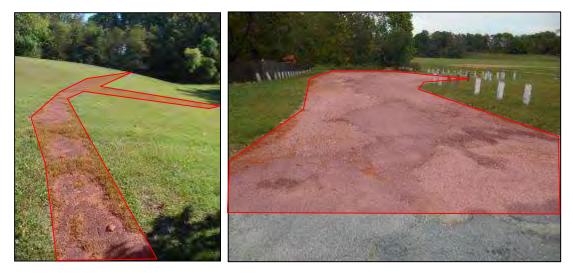
Figure 4-28: Examples of impervious cover removal opportunities at public schools ISI\_S\_0703 (Left) and ISI\_S\_0701 (Right).

in ISI\_S\_0701, the broken up pavement may be replaced with either pervious pavers or grass. These sites are illustrated in Figure 4-28.

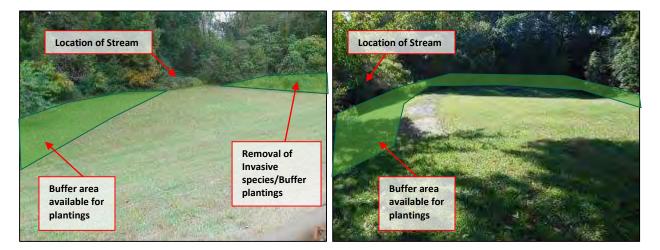
Buffer improvement was identified as a recommended action for five out of the 24 institutions assessed. These five sites include three faith-based facilities and two public schools. School properties typically represent a unique opportunity to combine restoration projects with education. The public schools recommended for buffer improvement are ISI S 0701 and ISI S 0703. The removal of invasive

Figure 4-30: Buffer Improvement Opportunity at ISI\_S\_0701 (Left) and ISI\_S\_0703 (Right)

shrubs/bushes and installment of buffer planting could be performed in conjunction with a stream cleaning and/or restoration project.

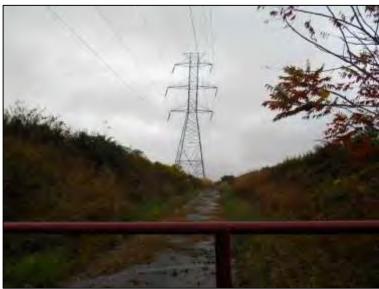
Located off of Cockeys Mill Road and straddling the Keyser Run and Norris Run subwatersheds, PAA\_S\_0502 is a narrow piece of land between I-795 southbound and a lumber/milling yard. The property is used as an easement for Baltimore Gas and Electric power lines. Due to the presence of the power lines, there is no potential for restoration and this site was not assessed further.

Figure 4-33: PAA\_S\_0502 is an easement for power lines and was not assessed for restoration opportunities

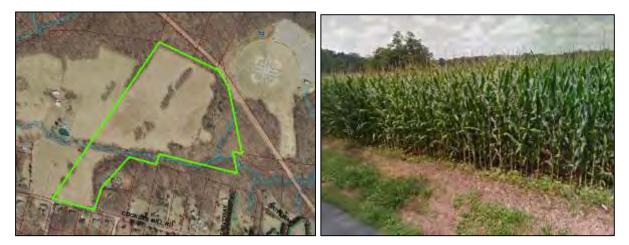
Located off of Cockeys Mill Road in the Keyser Run subwatershed, PAA\_S\_0503, is a 49.5 acre lot owned by Baltimore County. There is approximately 24 acres of open space with the potential for planting depending on desired land use. The parcel is zoned agricultural and currently appears to be at least partially used for agricultural purposes. Further investigation would determine the extent of land being actively cultivated. If all of the open space is being used for crops, trees will likely not be planted on the parcel. This would give the area a low priority. If, however, there is open space that is not being cultivated

Figure 4-34: PAA\_S\_0503 is a Baltimore County owned parcel that is partially farmed as seen from the view from Cockeys Mill Road. (Source, right: Google Map)

than the parcel would be a high priority area due to the potential to minimize an exterior forest gap and expand the buffer along approximately 570 feet of stream.

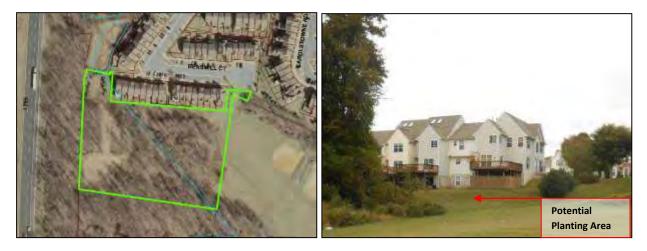
Located in the Norris Run subwatershed, PAA\_S\_0701, is a 3.6 acre lot owned by Baltimore County located behind Bensmill Court in the Stone Mill development. There is approximately 0.5 acres of open space with potential to plant. This open space has the potential to minimize an exterior forest gap. While this site is located on public land, the small area available for planting makes the site a low priority.

Figure 4-35: PAA\_S\_0701 is owned by Baltimore County and has the potential for tree planting in open space behind the Stone Mill development.

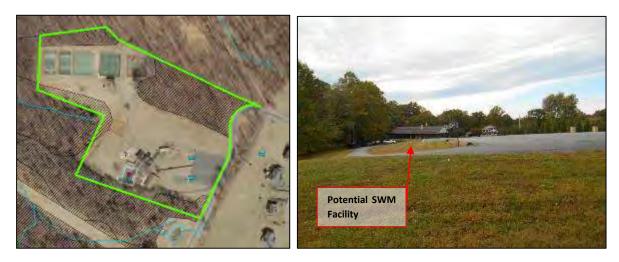
Figure 4-36: PAA\_S\_0901 is a privately owned parcel with potential for buffer expansion beyond the existing conservation easement and SWM retrofit

Located in the Timber Run subwatershed off of Saffell Road, PAA\_S\_0901 is a 14.6 acre property privately owned by the Green Valley Swim Club. Approximately 4.55 acres of the property is already under a Forest Conservation Easement (represented as hatching in Figure 4-36). There is opportunity to plant approximately 1 additional acre of trees beyond the existing conservation easement to further expand

the forested stream buffer. Plantings should be chosen with the intention to not block the line of sight from the building to the tennis courts. There are overhead power lines running across the mowed open space of the property, further limiting planting opportunities. There is also potential for storm water management retrofit to treat portions of the parking lot.

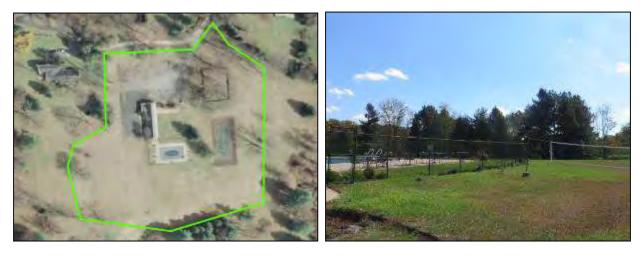
Figure 4-37: PAA\_S\_1101 is a privately owned swim club with potential for tree planting in the open space behind the swimming facility

Located off of Deer Park Road in the Liberty Reservoir-F subwatershed, PAA\_S\_1101 is a privately owned swim club in the neighborhood of Folly Quarter. The parcel has 2 acres of open space that is available for potential plantings. Proposed tree plantings would not expand interior forest or exterior forest gap; and therefore, the site is of low priority.

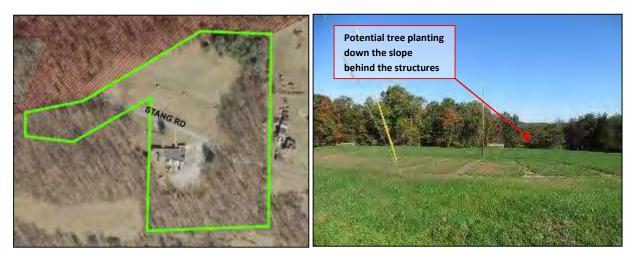
Figure 4-38: PAA\_S\_1201 is located adjacent to the Soldiers Delight Natural Environment Area and has open space with potential for tree planting between the structures and the wood line

Located in the Chimney Branch subwatershed, PAA\_S\_1201 is an 8.1 acre parcel privately owned by the Knights of Columbus. The parcel is located off of Stang Road, east of Wards Chapel Road, and is bordered to the north by the Soldiers Delight Natural Environmental Area. There is 0.5 acres of open space located adjacent to the Soldiers Delight land that is potentially available for tree planting. This planting will minimize the existing exterior forest gap. Planting this area will also expand existing forest but will not expand interior forest land. There are no streams within the parcel limits and no opportunities for storm water retrofit.

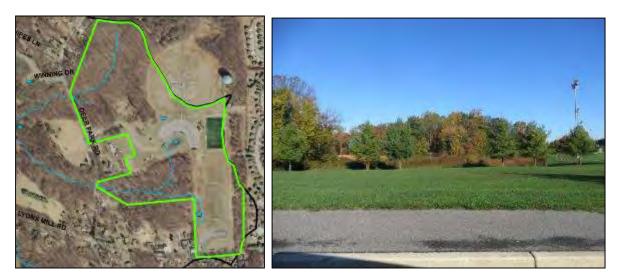
Figure 4-40: PAA\_S\_1402 is a county park with potential planting opportunities throughout the site

Located in the Locust Run subwatershed on the border of the Liberty Reservoir watershed with the Gwynns Falls watershed, PAA\_S\_1402 is the county managed Northwest Regional Park. The site currently treats its runoff with three existing storm water management facilities. Four open space locations on the site totally approximately 3.5 acres have the potential for tree planting. Three of these sites would expand continuous forest but not forest interior, and one of the sties would minimize an existing forest gap. The

streams on this site already have adequate forest buffer. Therefore, this site is a low priority for restoration.
